Lake Trace Vegetation Survey Report

September 2023

North Carolina State University

Carolina Trace Lake & Dam Committee

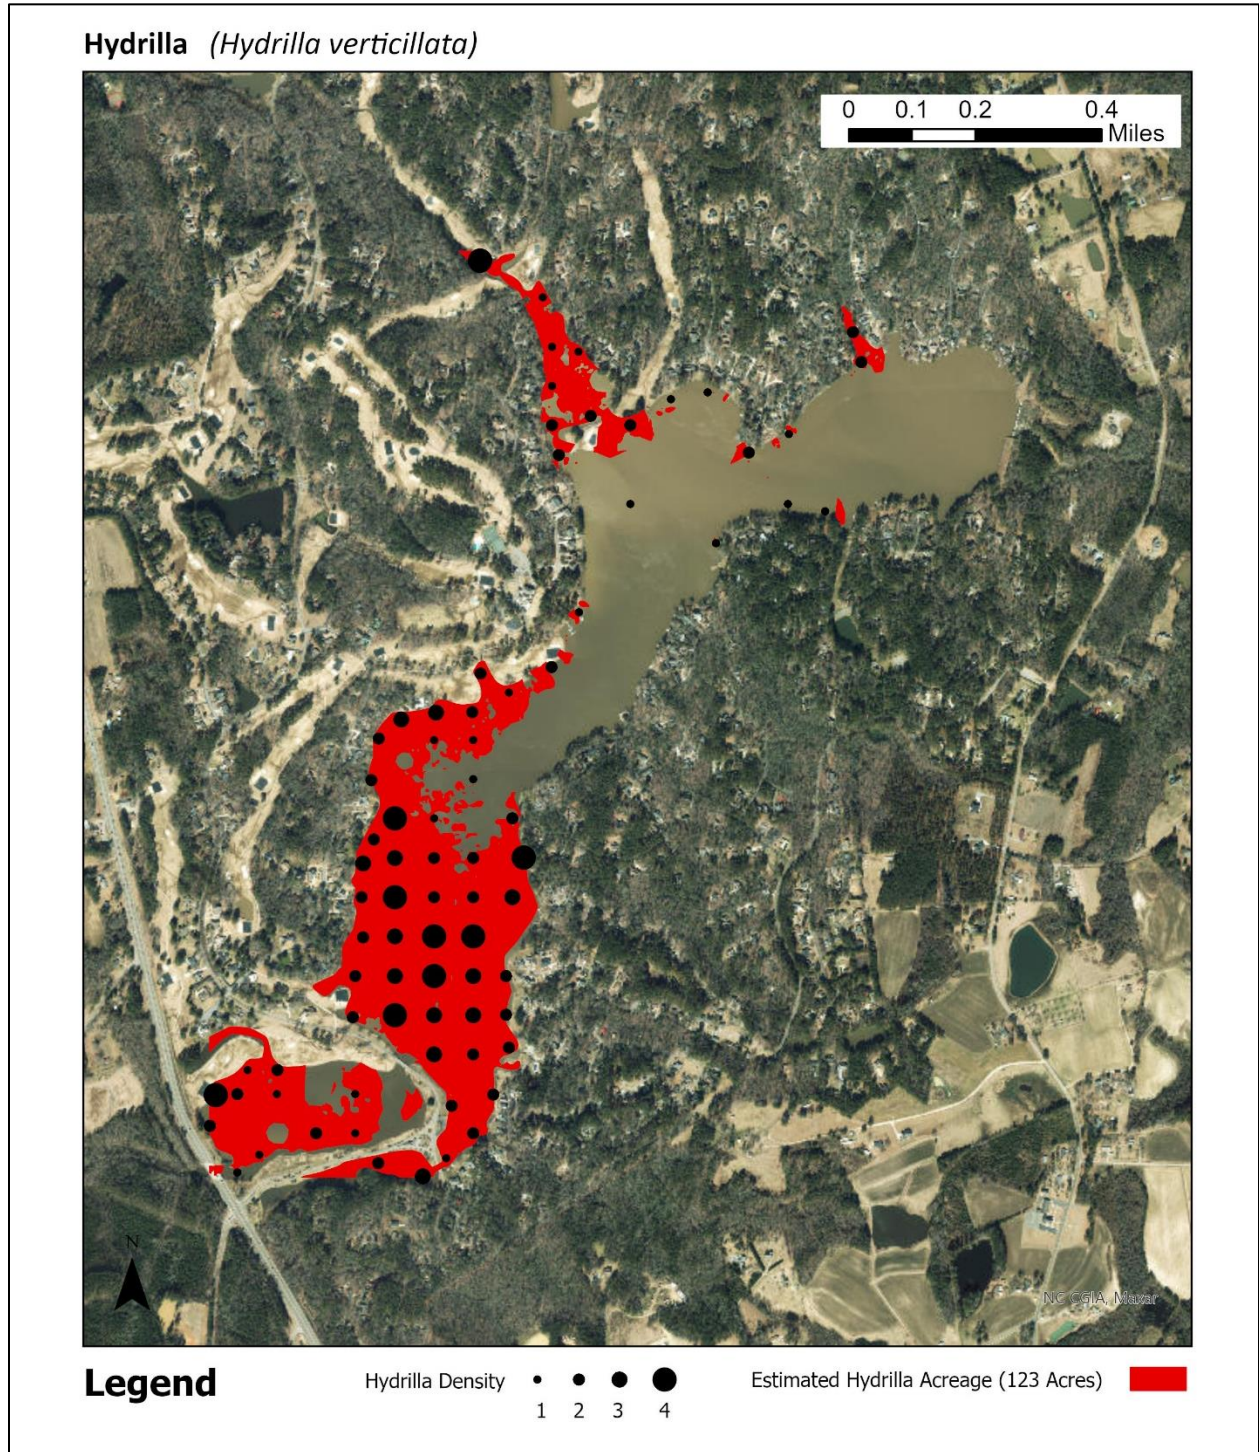
Based on survey efforts, hydrilla has become well distributed within the lake, and the plant covers an estimated 123 acres of the waterbody (Figure 3). The mean biovolume of all submersed vegetation within Lake Trace was 15%, with the highest biovolume recorded in the Carr Creek arm and throughout the southern portion of the lake (Figure 5). Generally, submersed vegetation was present in water depths that were < 6 feet (Figures 5 and 6).

Figure 3: Hydrilla distribution and abundance determined during the 2023 survey of Lake Trace.

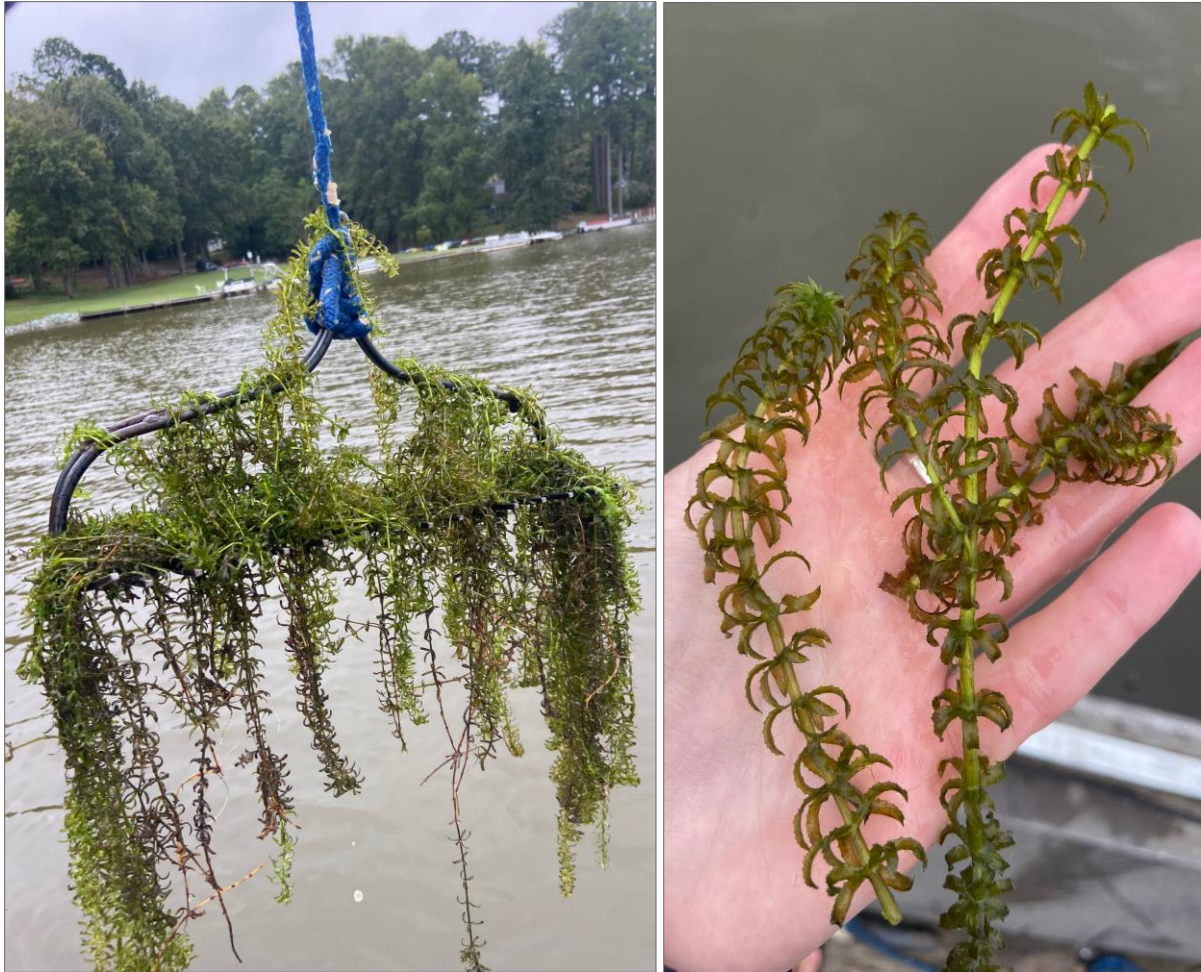
Figure 4: Example of hydrilla density estimation using rake toss method at Lake Trace during the 2023 survey (left: density rating of '4'; right: density rating of '1').

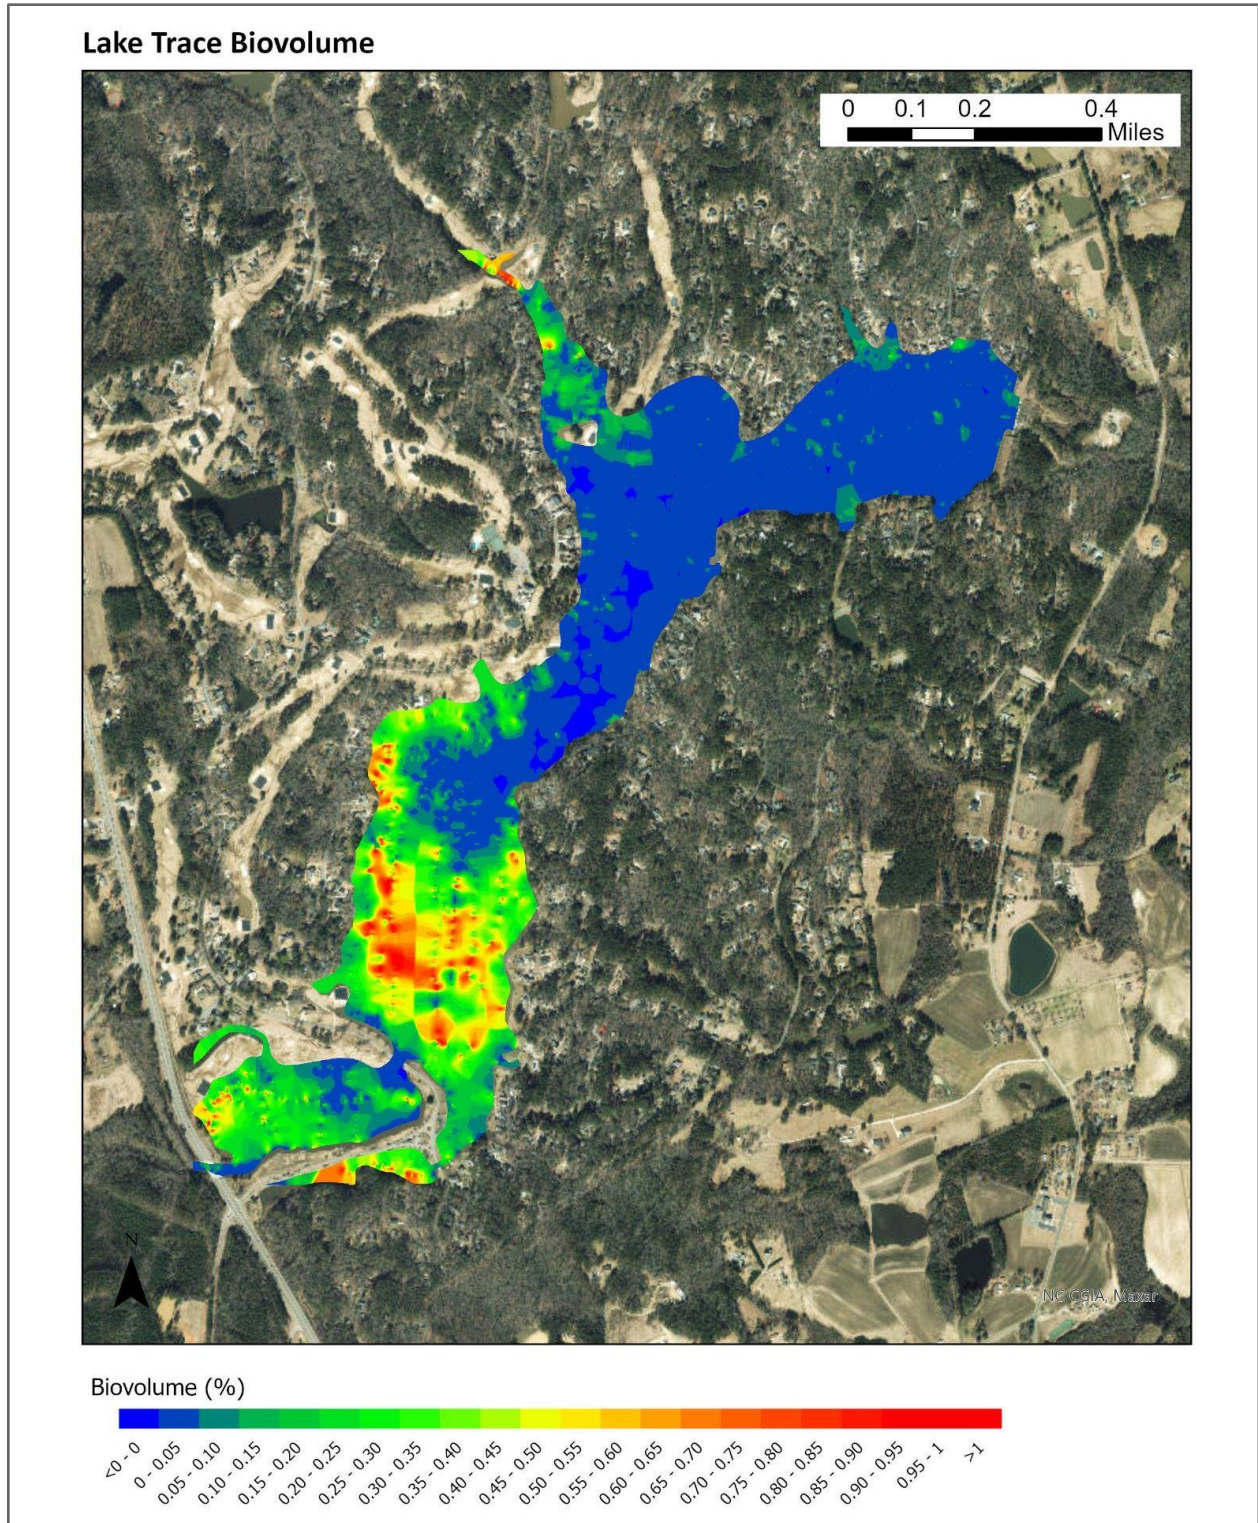
Figure 5: SAV Biovolume recorded at Lake Trace during the 2023 survey. Cool (blue) colors represent low biovolume areas and warm (red) colors represent high biovolume areas.
